## **Affected equipments : Metal Cutaway Handles for Tandem / MMS** **Ref: P2010167600 & P1010167600**

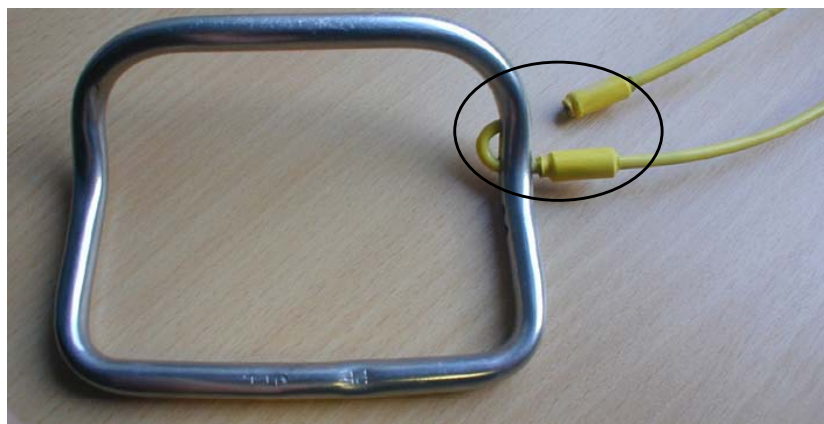
A user reported the breaking of one of the coated cables of a MMS metal cutaway handle for main canopy (ref P1010167600). The breaking occurred at the contact point between the coated cable and the upper drilling of the metal handle. The affected handle is 11 years old, this model has been discontinued since 1998.

The repetitive bendings of the metal part of the cables, at their contact point with the metal handle, have caused the ageing and the weakening of the cable resistance. The metal cutaway handles for Atom Tandem (ref P201016700), which are identical to the MMS metal cutaway handles, are bound to be affected.

1. To be done RIGHT NOW : Inspect the cables at their contact point with the handle. Replace any handle the cables of which would show signs of breaking.
2. To be done AS SOON AS POSSIBLE : Replace all the handles even though the cables do not show any signs of breaking.
